**MULTI-MEDIA COMPLIANCE EVALUATION INSPECTION
U.S. ENVIRONMENTAL PROTECTION AGENCY
REGION III
OFFICE OF ENFORCEMENT, COMPLIANCE, & ENVIRONMENTAL JUSTICE**

**American Zinc Recycling Corporation
(formerly Horsehead Corporation)
900 Delaware Ave
Palmerton, Pennsylvania 18071**

Inspection Dates: 14-18 May 2018

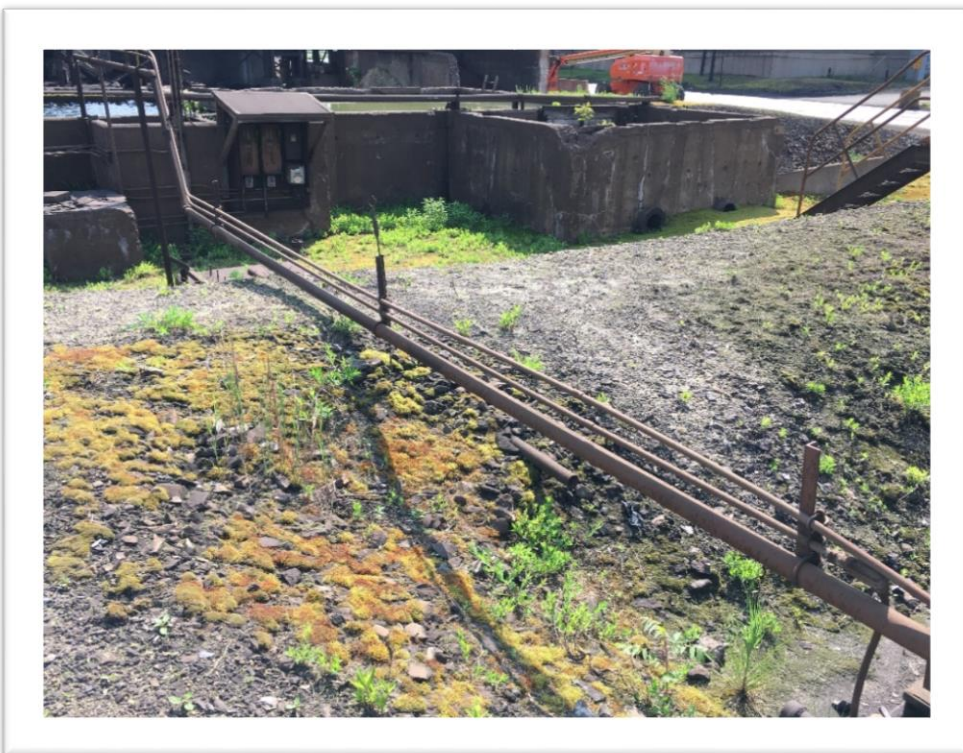
Tank No. 002A is a 20,000-gallon fuel oil tank, see Photos 131 and 132. At the time of the Inspection, the diked area was free of vegetation, dry and in good shape. Based on the ICP, the secondary containment capacity is 47,759 gallons and the dike is made of clay. An open pipe (no cap or valve to control flow of fluid on both sides) was observed through the berm, see Photos 133 and 134. Another pipe, this one connected to the AST, and passing on top of the diked area, was supported by a piece of wood (see Photo 135).

Photo 133. (IMG_0361.JPG): Open Pipe at Tank No. 002A – 20,000-gallon Fuel Oil AST.

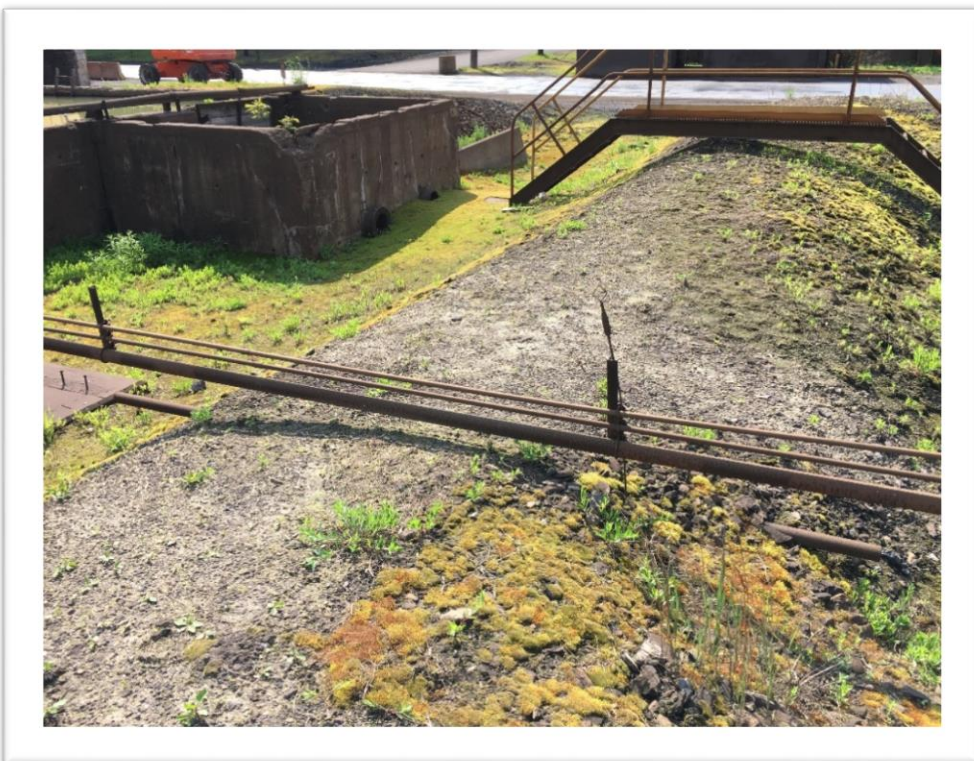
Photo 134. (IMG_0362.JPG): Another View of Pipe with no caps or valves at Tank No. 002A.

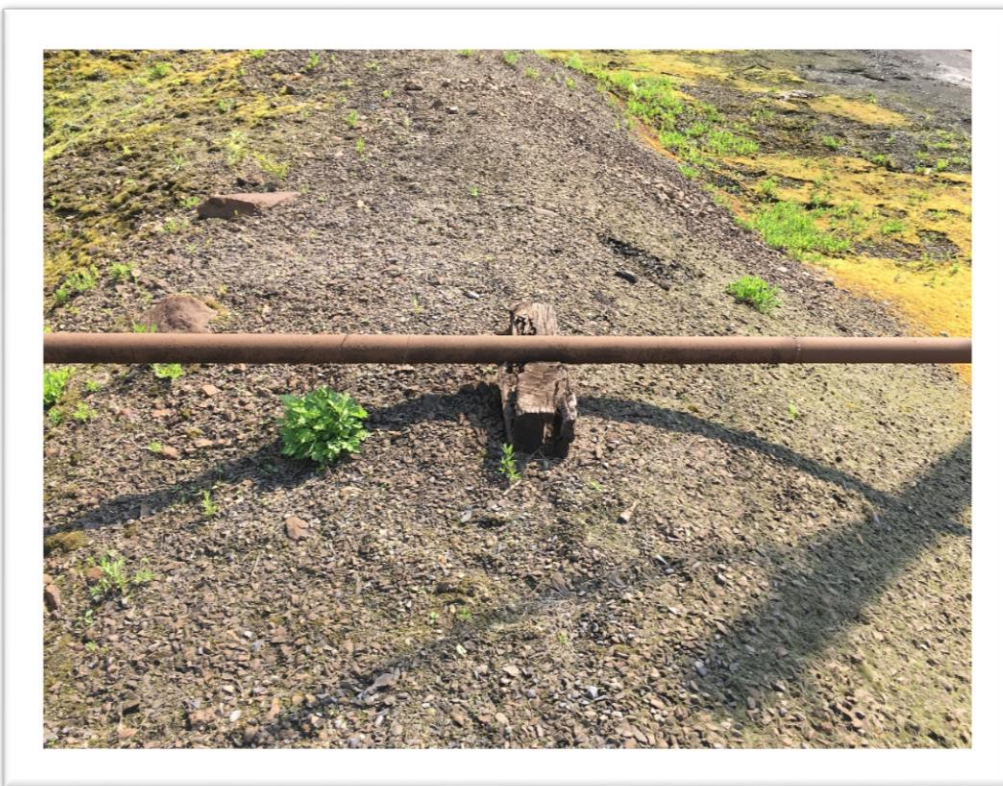
Photo 135. (IMG_0363.JPG): Wood Supporting Pipe at Tank No. 002A.

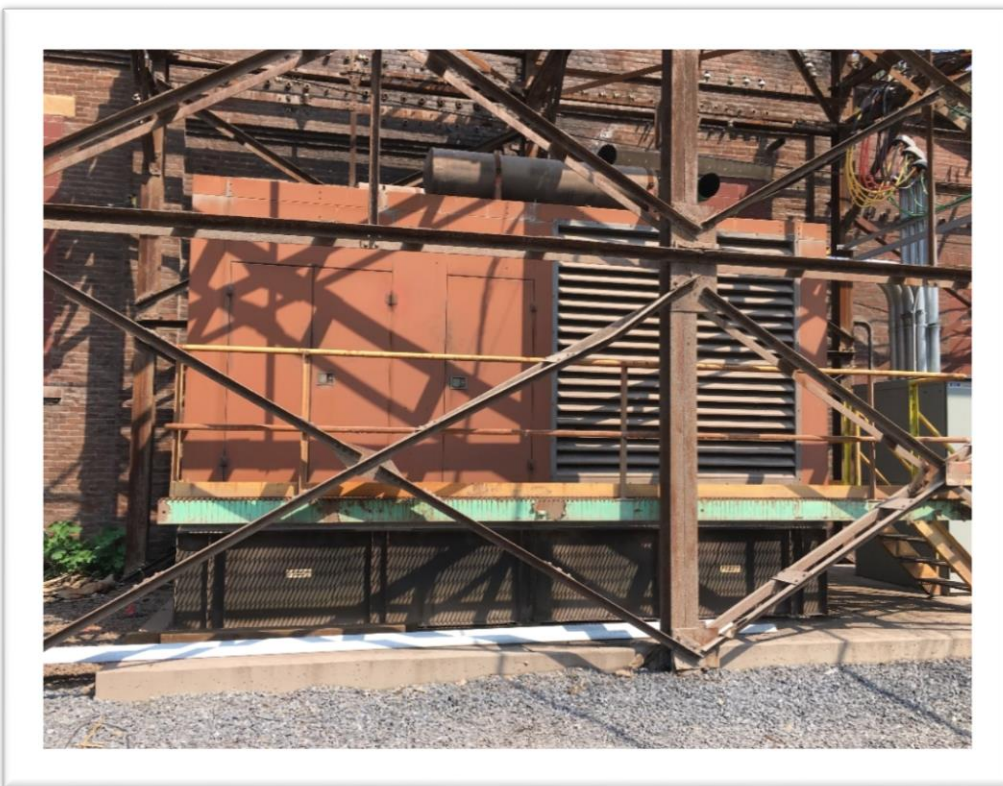
EPA inspectors Jiménez and Hernández-Vega observed an emergency power generator, (see Photo 136), located at Kiln 1. Based on the ICP, the emergency power generator has a diesel fuel tank with capacity for 2,005 gallons. EPA inspectors Jiménez and Hernández-Vega noted a wet area on the back of the unit, see Photo 137. The liquid from the wet area and the liquid did not have an oil or fuel type viscosity and had no smell of organic fluid. The wet area appeared to be a fuel stain.

Photo 136. (IMG_0364.JPG): Emergency Power Generator at Kiln 1.

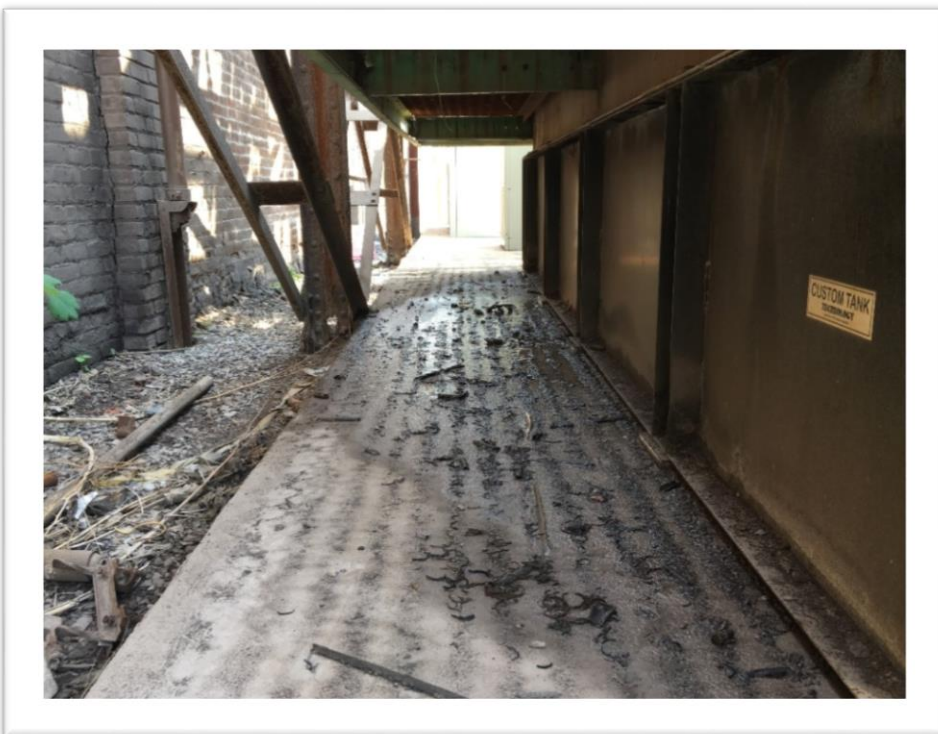
Photo 137. (IMG_0365.JPG): Wet Area on the Back of Emergency Power Generator at Kiln 1.

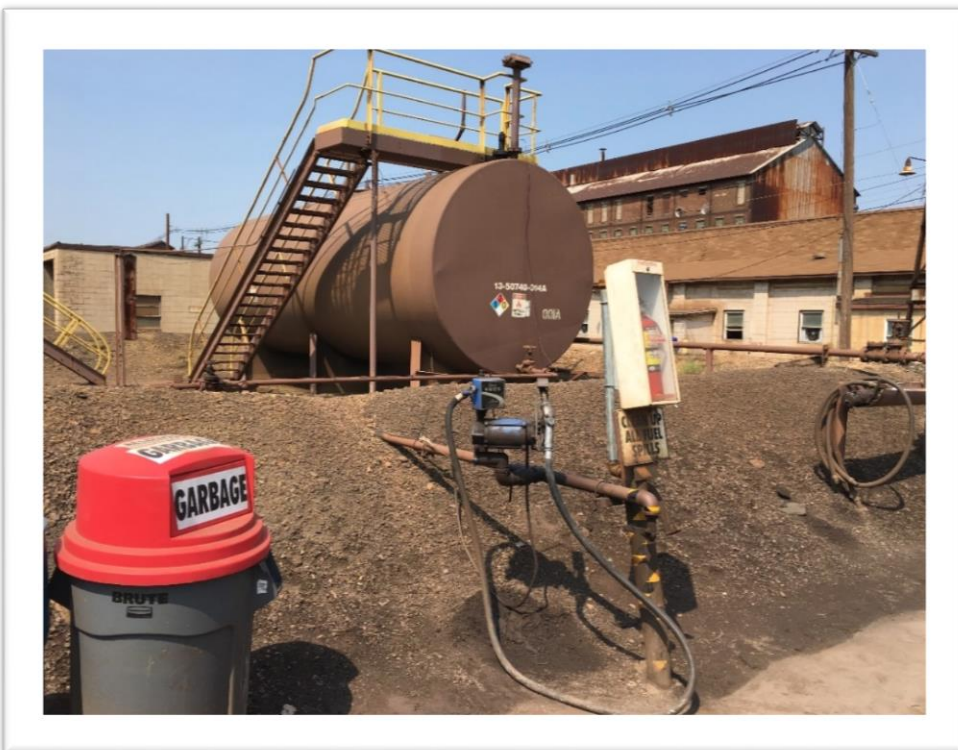
EPA inspectors Jiménez and Hernández-Vega observed Tank No. 001A, a 20,000-gallon diesel fuel AST, see Photo 138. This AST had the same configuration as Tank No. 002A. A pipe coming across the diked area, similar to the pipe observed at Tank No. 002A, was observed by EPA inspector Jiménez at Tank 001A, but this pipe had a valve on the end leading to outside of the diked area. No concerns were observed by EPA inspectors Jiménez and Hernández-Vega.

Photo 138. (IMG_0369.JPG): View of Tank No. 001A, a 20,000-gallon Diesel Fuel AST.

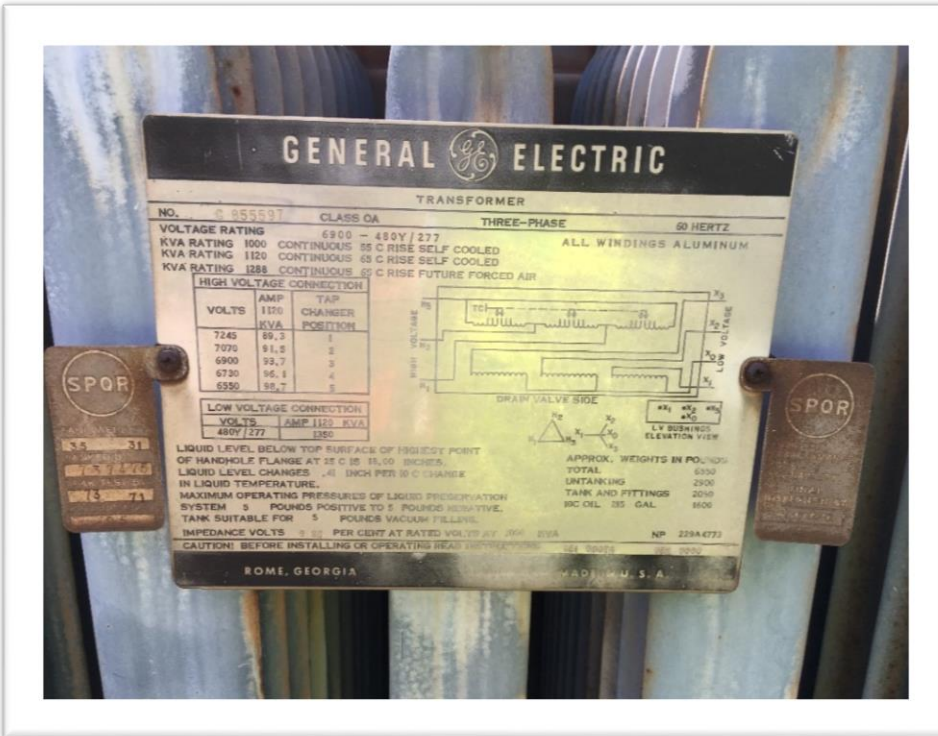
Transformer G855597 contains 215 gallons of oil with no PCBs (see Photos 139 and 140.). No leaks were observed at the time of the Inspection.

Photo 139. (IMG_0370.JPG): TX S/N G855597 Nameplate.

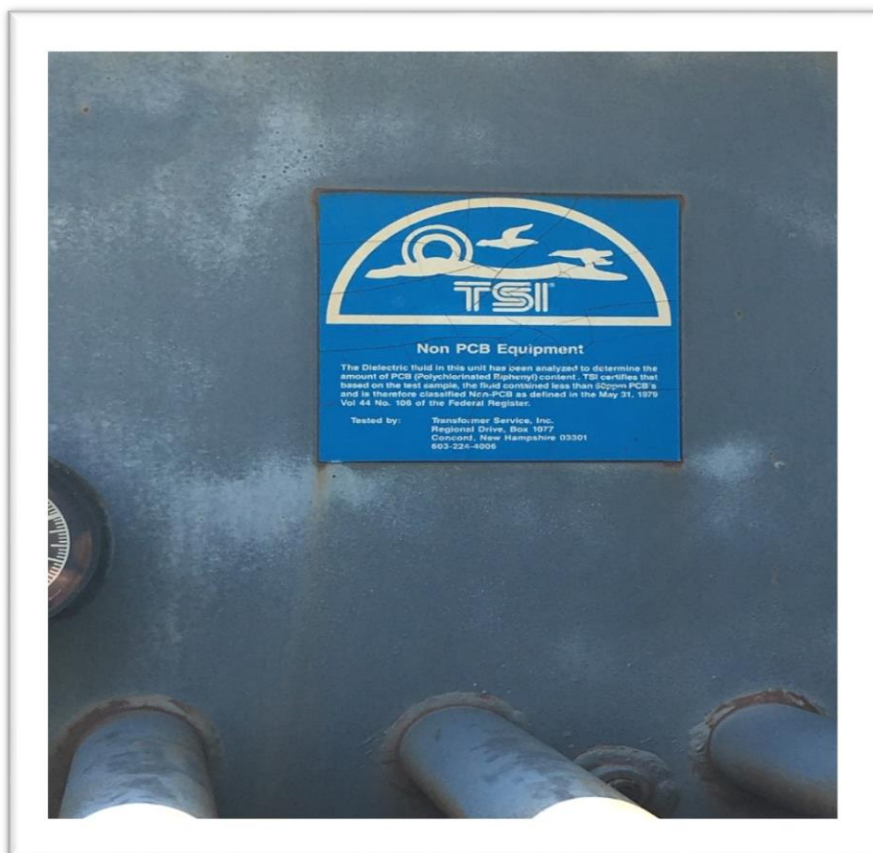
Photo 140. (IMG_0371.JPG): TX S/N G855597 Blue Label.

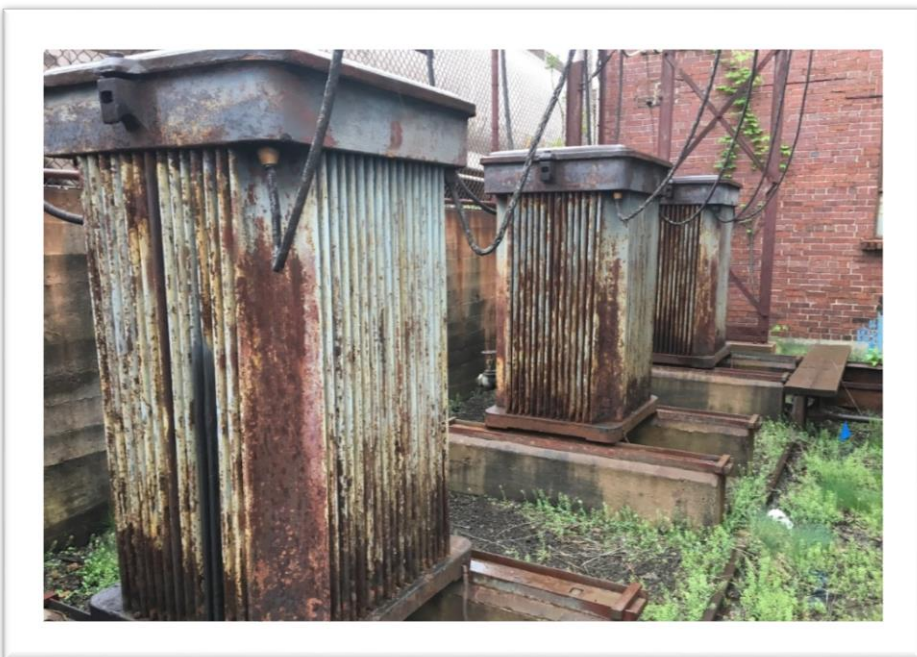
EPA inspectors Jiménez and Hernández-Vega observed three oil-filled transformers (see Photo 141). Based on the nameplates, these transformers were built early 1900's. The serial numbers associated to these transformers were: 391166, 391162 and 391161. The transformers were not in use, and were not leaking. Based on the ICP, the oil volume is less than 55 gallons.

Photo 141. (IMG_0381.JPG): View of three Oil-filled Transformers at Electrical Substation No. 27.

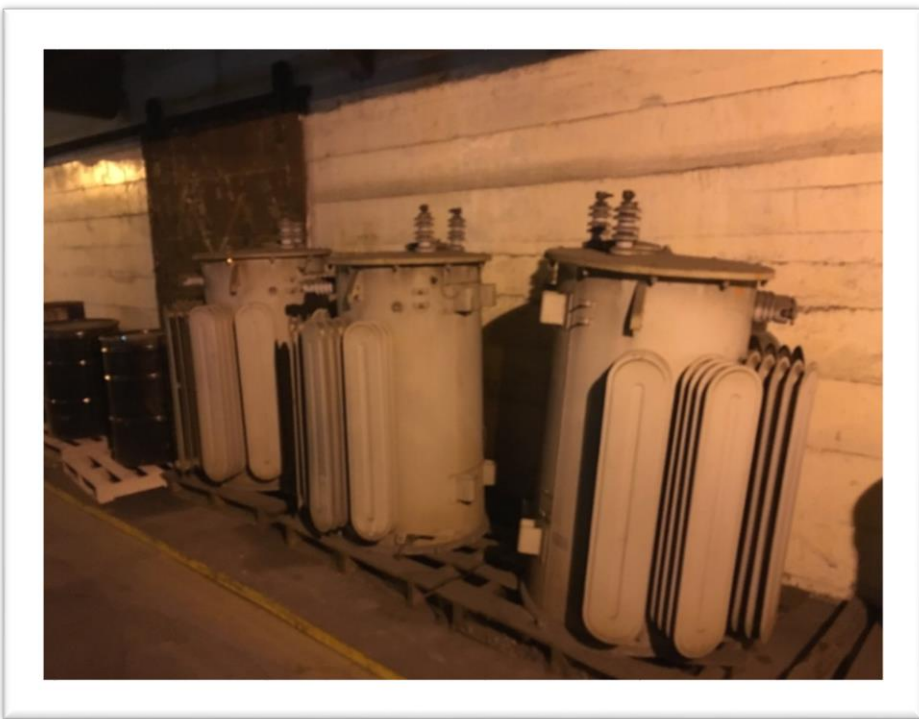
Three oil-filled transformers were stored at this location (see Photo 142). The transformers were situated in an area where a leak from the transformers could be contained (see Photo 143). Based on the nameplate, these transformers do not contain PCBs. The transformers were not leaking at the time of the Inspection.

Photo 142. (IMG_0387.JPG): Three Oil-filled Transformers at Storage Building.

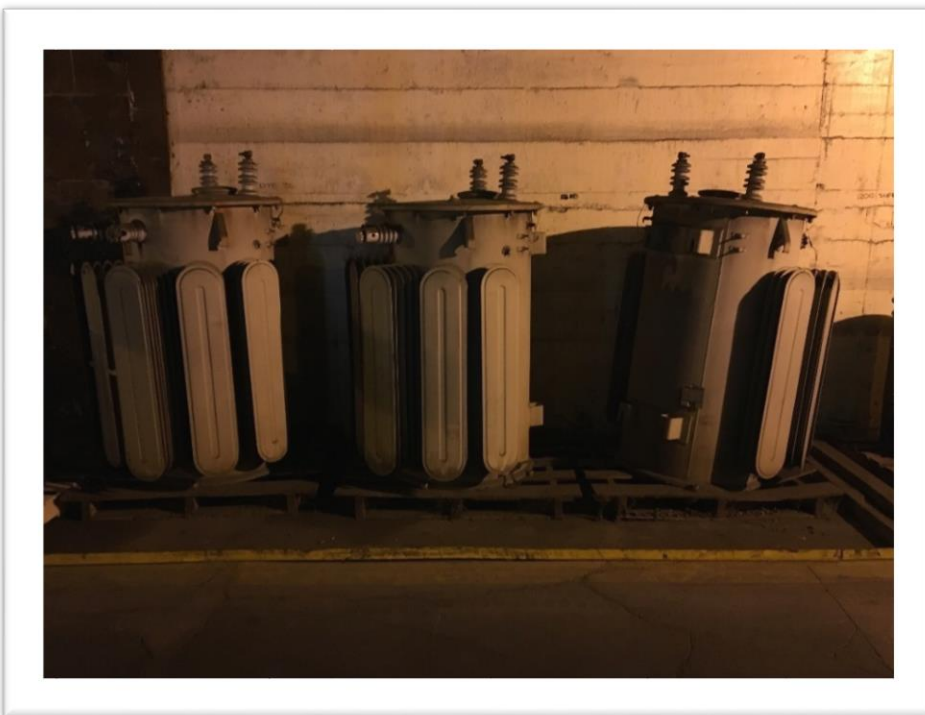
Photo 143. (IMG_0389.JPG): Another View of Three Transformers at Storage Building.

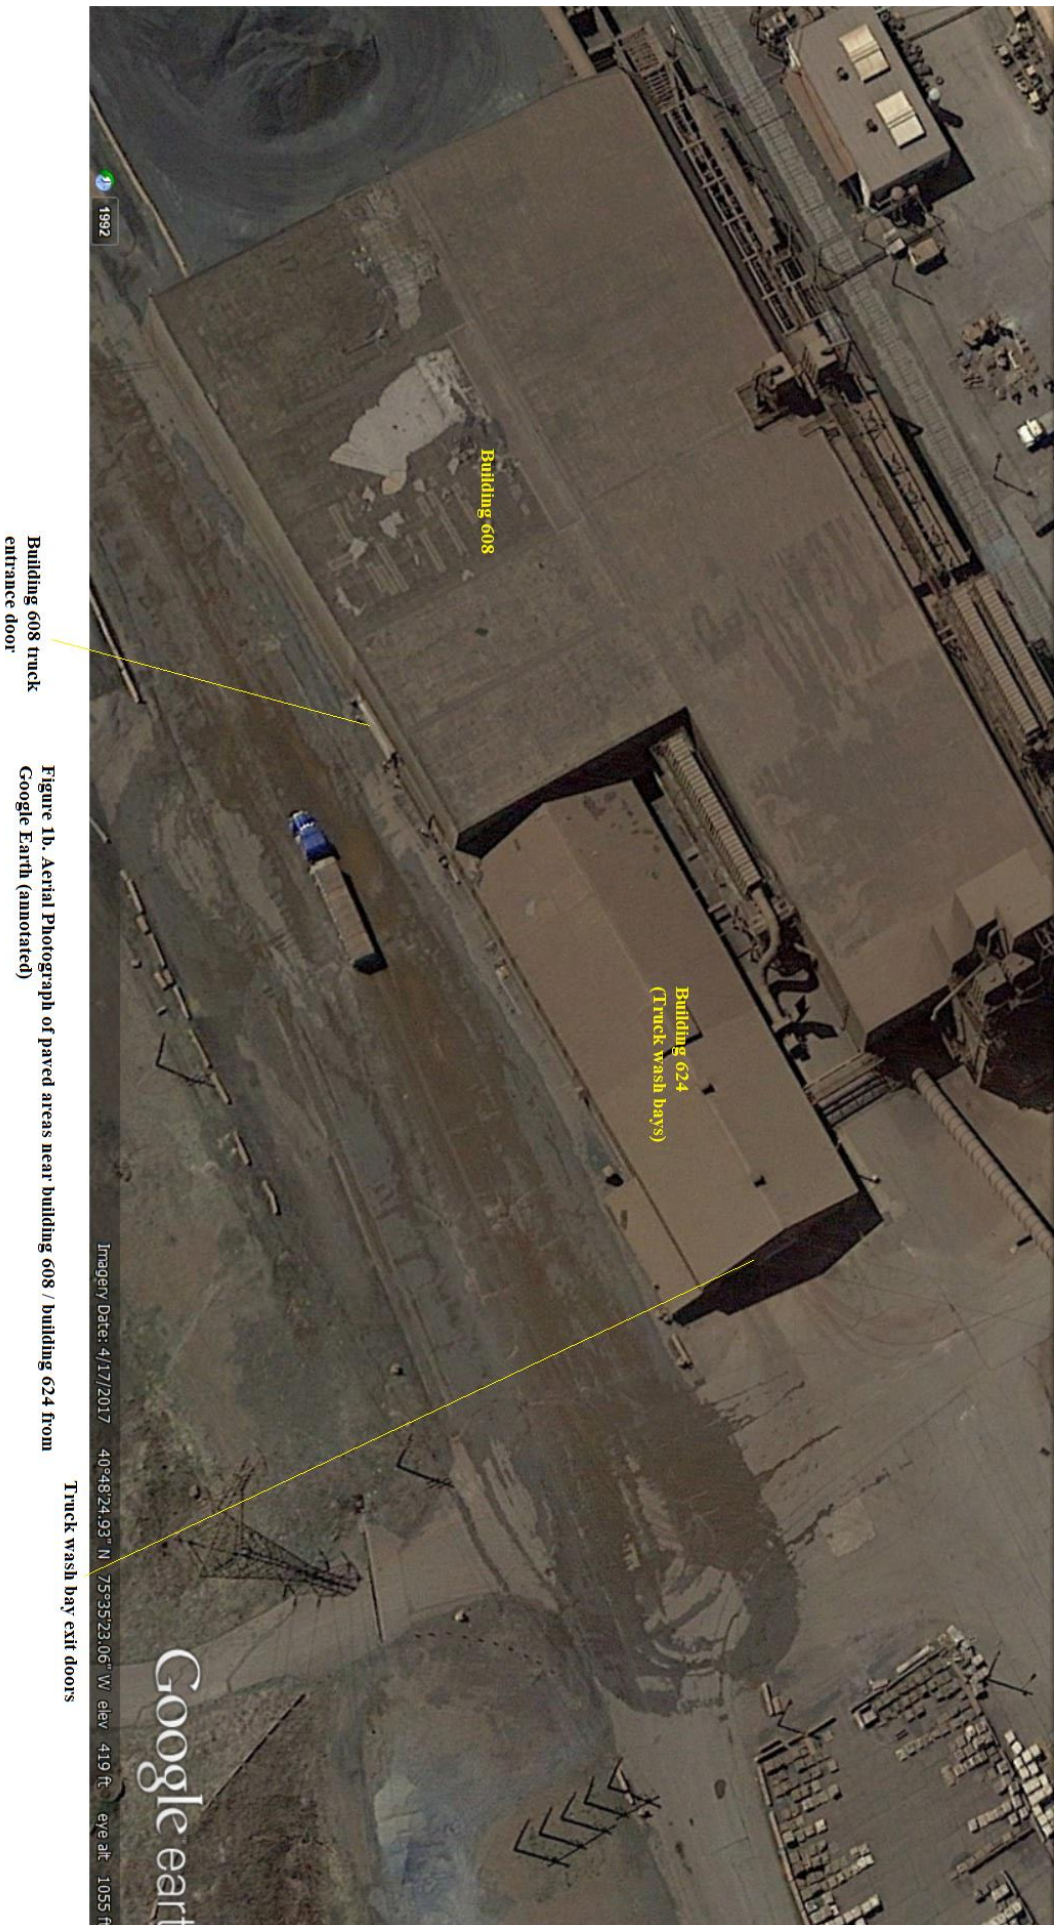
Figure 1b. Aerial Photograph of paved areas near building 608 / building 624 from
Google Earth (annotated)

EPA inspectors note that brown streaks are also visible in an arc that originate at the wash bay exits and curve northward, on the aerial photograph available on Google Earth (see Figure 1b).
